RE: Wetland Application Review - Interim Report
10-14 Merritt Avenue
Woodbridge, CT

**Interim Environmental Review Report
Proposed Development
10-14 Merritt Avenue – Woodbridge, CT
April 26, 2022**

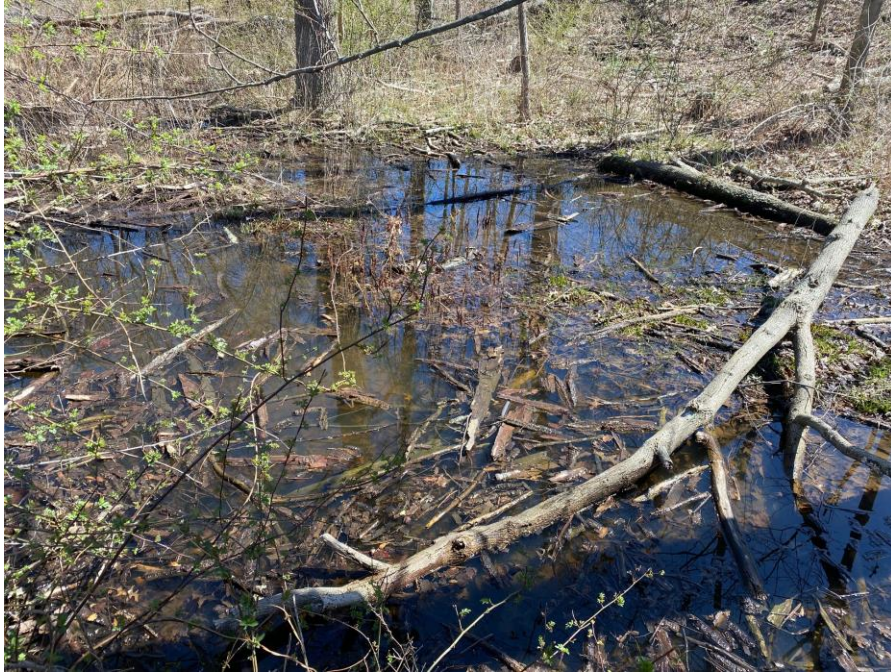
MBI met Bill Kinney on the site on April 11, 2022, and we completed a site walk. The eastern wetlands area is largely located offsite and receives some stormwater flow from the adjacent highway. Based on the size and depth of the ponded areas, coupled with the size and nature of adjacent and nearby upland

habitat, it appears unlikely that they would provide any significant Vernal Pool habitat. However, confirmational data is required to be conclusive.

Area of standing water in eastern wetlands

Additional documentation of “spring visits” confirming the eastern wetlands do not provide Vernal Pool habitat should be provided. Such documentation could include visual assessment of egg masses and amphibians, auditory surveys of calls, and physical evaluation of suitable hydrology.

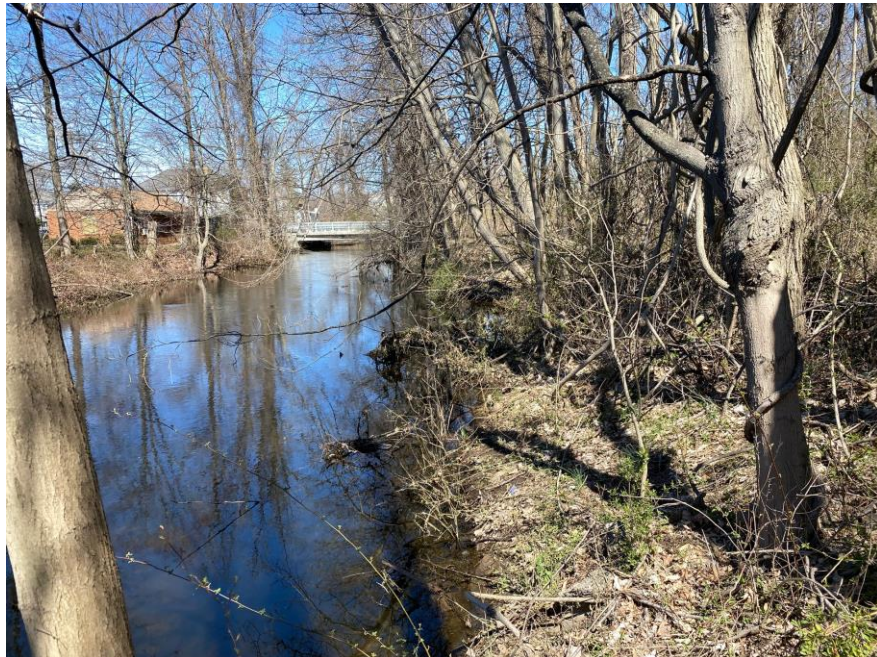
The area along the West River has been disturbed and includes areas of fill material and debris as well as two former homeless encampments. The area is thick with invasives but does offer native tree cover along the river.

View looking north along east bank of river.

The plan should identify and preserve the onsite mature trees along riverbank. These trees provide shoreline stabilization, shade and habitat value. The plan should specifically identify which such trees require removal to facilitate proposed drainage features (emergency spillway) and the compensatory flood storage area.

Removal of invasives and fostering healthy growth of native trees along the river should be integrated into a 3-year monitoring and maintenance plan.
