**RE: PRELIMINARY APPLICATION REVIEW**

**Proposed Residential Development, Fountain Street LLC**  
804 Fountain Street, Woodbridge, CT

*REMA Job #: 25-2817-WDB5*

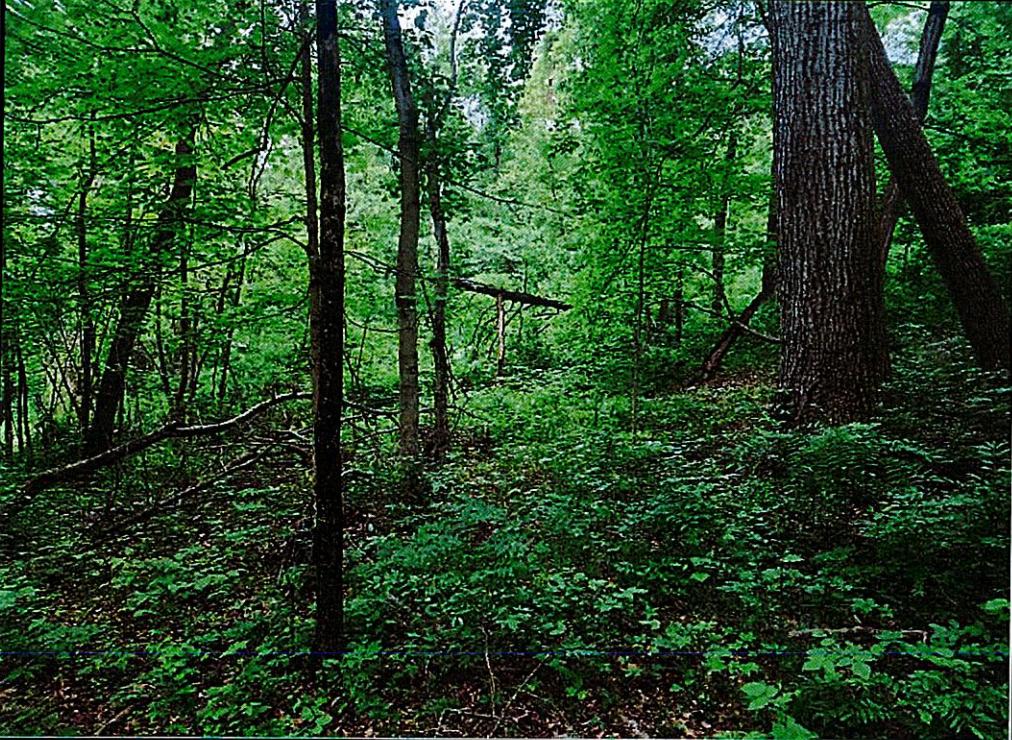
<b>SITE/LOCATION:</b> Proposed Residential Development 804 Fountain Street Woodbridge, CT	REMA JOB NO.: 25-2817-WDB5	<b>ANNOTATED PHOTO LOG</b>
	<b>INVESTIGATOR(S):</b> G.T. Logan, PWS; S.N. Gadwa, PWS		
<b>DATE:</b> May 21, 2025	<b>FACING:</b> SOUTHERLY	<b>PHOTO NO.:</b> 1	<i>Comments:</i> Post-agricultural portion of site (northeasterly)

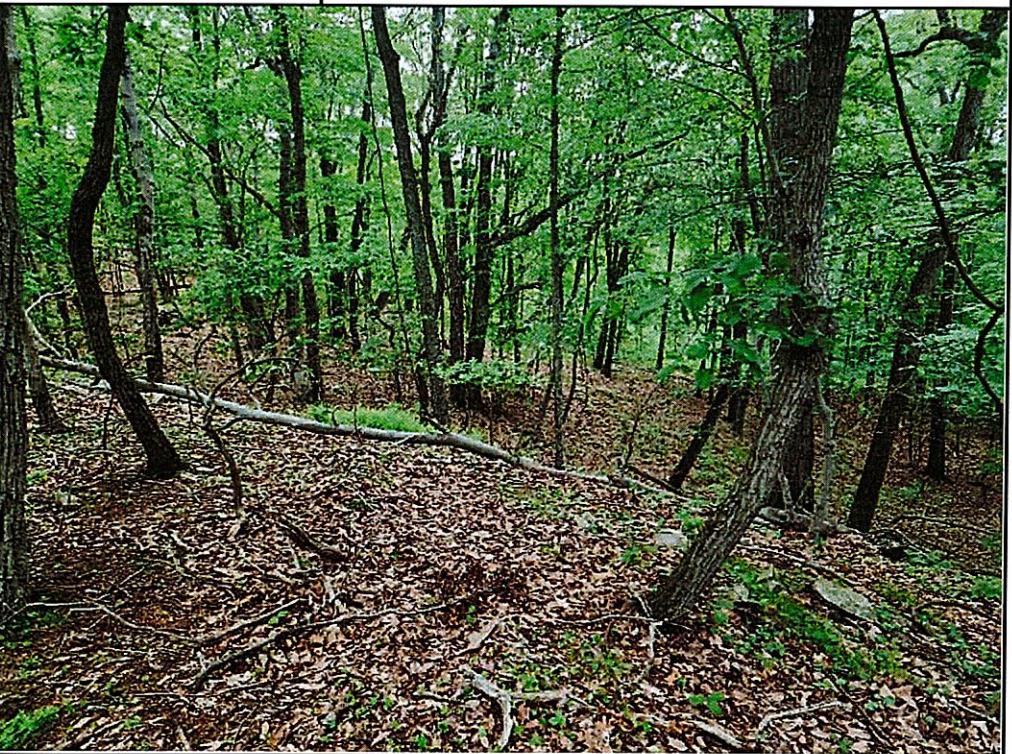
<b>DATE:</b> May 21, 2025	<b>FACING:</b> NORTHEASTERLY	<b>PHOTO NO.:</b> 2

<i>Comments:</i> Mature, second-growth woods; viewed from near the top of the parcel

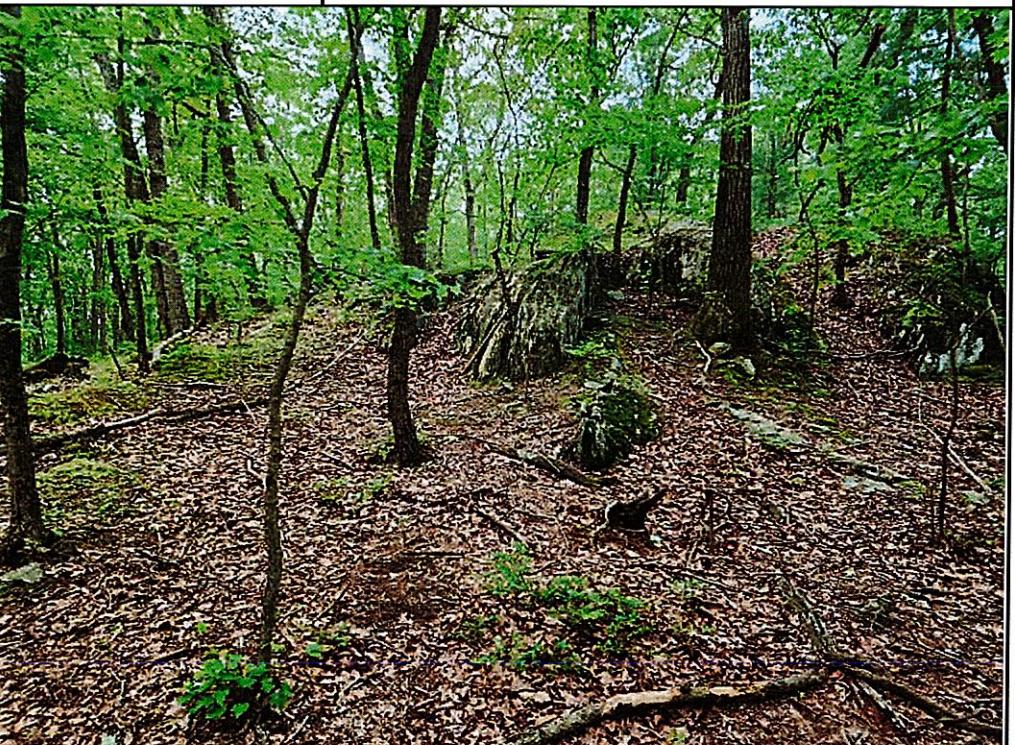
<b>REMA</b>	<b>SITE/LOCATION:</b> Proposed Residential Development 804 Fountain Street Woodbridge, CT  <b>INVESTIGATOR(S):</b> G.T. Logan, PWS; S.N. Gadwa, PWS	REMA JOB NO.: 25-2817-WDB5	<b>ANNOTATED PHOTO LOG</b>
<b>DATE:</b> May 21, 2025	<b>FACING:</b> NORTHERLY	<b>PHOTO NO.:</b>	<b>5</b>

<p><i>Comments:</i> Ridgetop portion of subject site with unique bedrock geology and flora and lack of invasive plant species</p>

The ridge crest community, both onsite and off-site, will be degraded by invasives without the protective barrier of hundreds of feet of tall mature forest. Currently, its ecological value as an example of a classic ridgetop plant community (“a unique natural feature”), is much enhanced by the fact that invasive plant species are almost entirely absent, although the disturbed swath bordering the highway and the former farm fields by Fountain Street are severely infested. The ridgetop is currently shielded by the long (about 150-foot), densely treed hillside, with limited bird activity due to highway noise. Forests “filter” windblown invasive seeds that do not germinate in forest shade, but sprout readily on open outcrops. Similarly, the taller traprock ridge crests, like most of Mount Higby in Middletown, have few invasives, due to long, forested protective slopes, though most low trap ridges are severely infested. For geology or earth science – or ecology - students at all levels, conduct field trips to this series of outcrops.

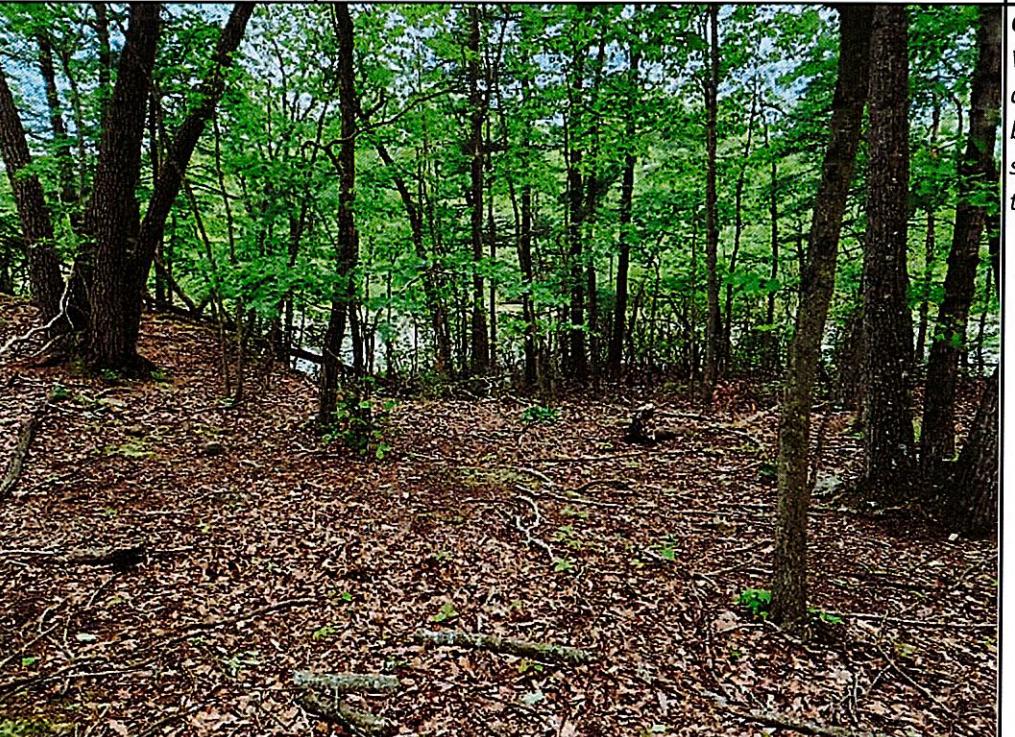
<b>DATE:</b> May 21, 2025	<b>FACING:</b> WESTERLY	<b>PHOTO NO.:</b>	<b>6</b>

<p><i>Comments:</i> View of Woodbridge Land Trust property and Bishop's Pond (in background), as viewed from subject site within a few feet of the property boundary</p>

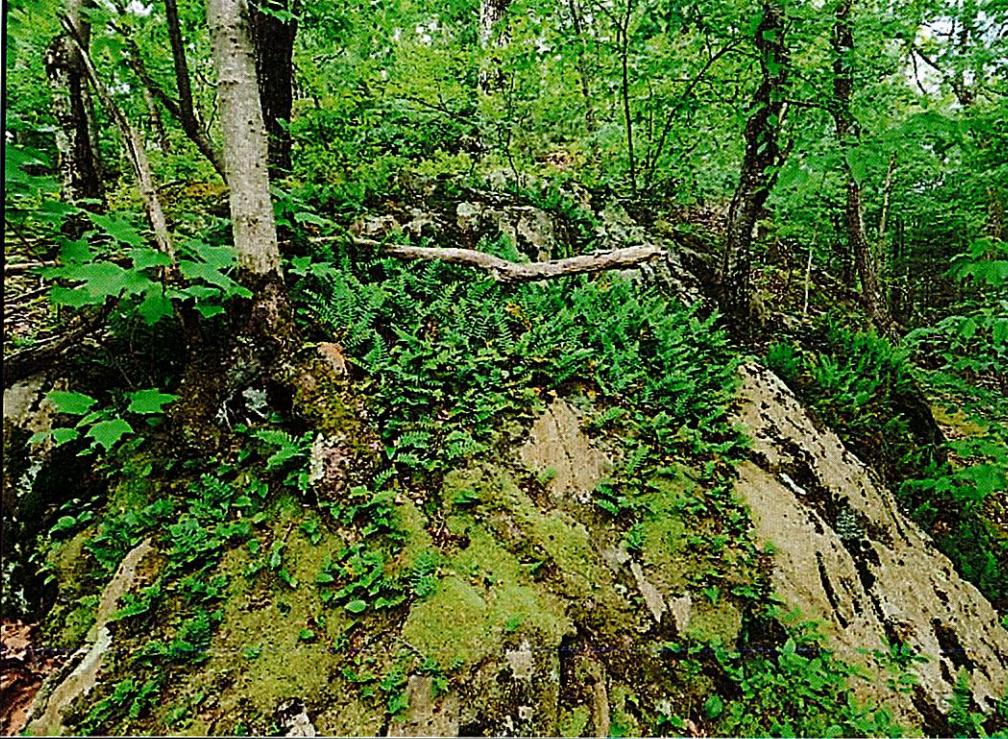
<b>SITE/LOCATION:</b> Proposed Residential Development 804 Fountain Street Woodbridge, CT	<b>REMA</b> <b>JOB NO.:</b> 25-2817-WDB5	<b>ANNOTATED</b> <b>PHOTO LOG</b>	
	<b>INVESTIGATOR(S):</b> G.T. Logan, PWS; S.N. Gadwa, PWS			
<b>DATE:</b> May 21, 2025	<b>FACING:</b> NORTHERLY	<b>PHOTO NO.:</b> 9	<b>Comments:</b> The subject site contains much exposed moss and lichen encrusted bedrock, which will be exposed to invasive species proliferation and desiccation; Note polyody fern.

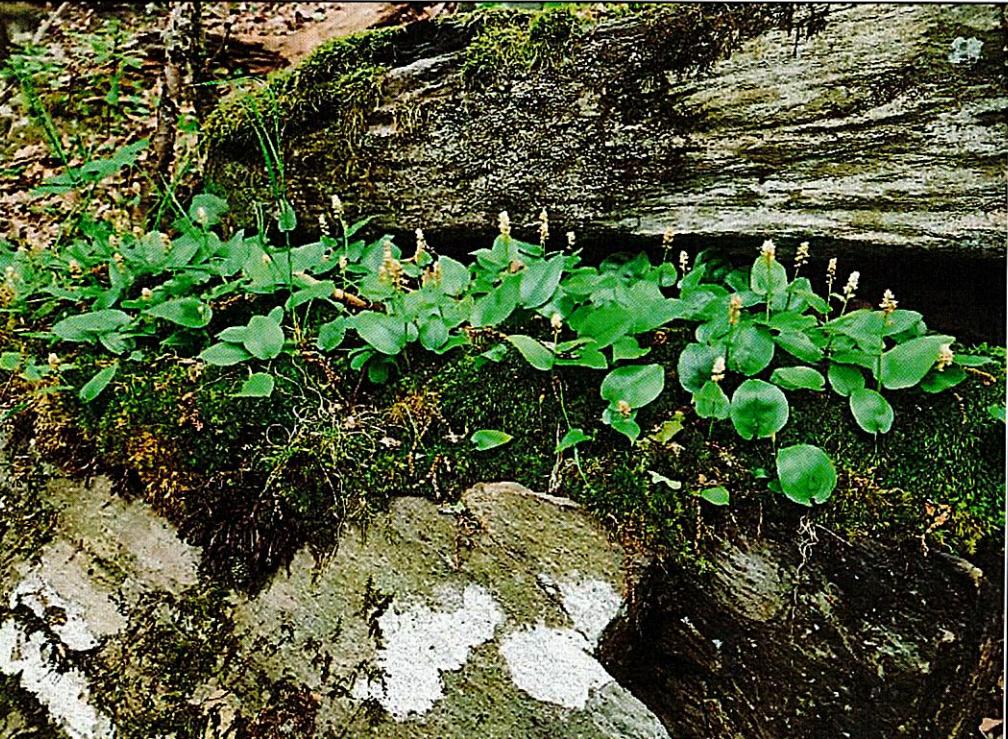
<b>DATE:</b> May 21, 2025	<b>FACING:</b> N/A	<b>PHOTO NO.:</b> 10	<b>Comments:</b> Unique bedrock geology provides habitat for rock loving plants and mosses, and high aesthetic, educational, and recreational potential. Canada mayflower ( <i>Maianthemum canadense</i> ) patch in view.

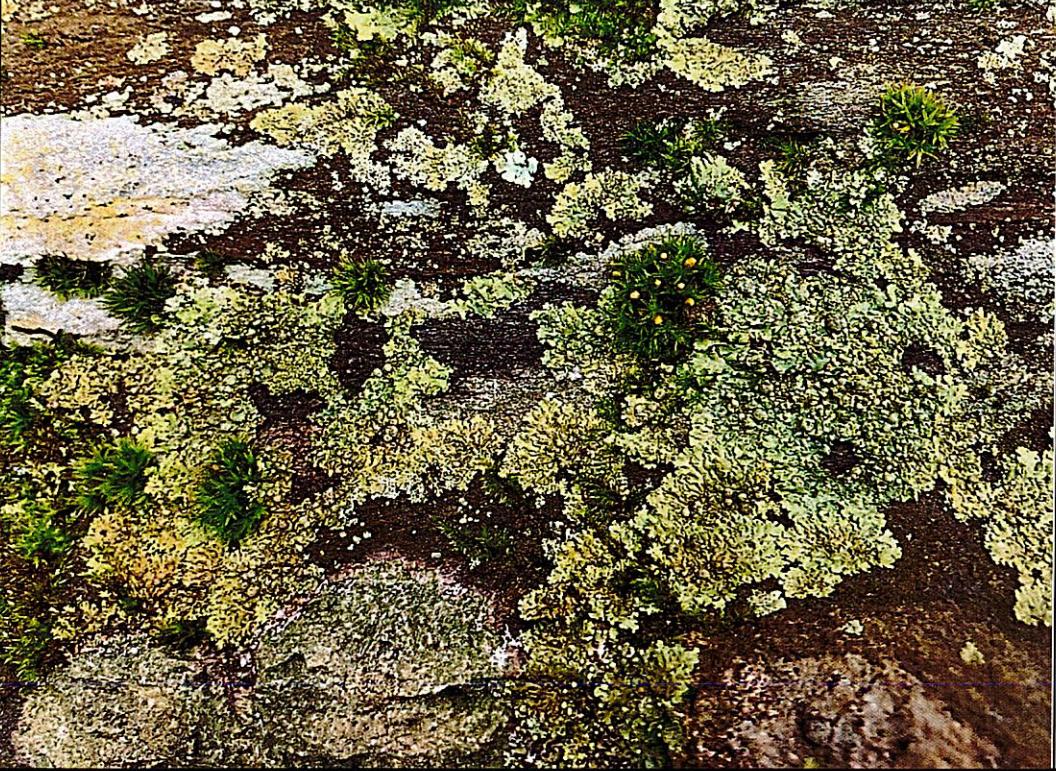
<b>SITE/LOCATION:</b> Proposed Residential Development 804 Fountain Street Woodbridge, CT	<b>REMA JOB NO.:</b> 25-2817-WDB5	<b>ANNOTATED PHOTO LOG</b>
	<b>INVESTIGATOR(S):</b> G.T. Logan, PWS; S.N. Gadwa, PWS		
<b>DATE:</b> May 21, 2025	<b>FACING:</b> NA	<b>PHOTO NO.:</b> 11	<i>Comments: Lichens and moss on west-facing rock.</i>

Lichen diversity and density is comparable to that on traprock ridges in rural areas with clean air; the suite of species photographed at this site are also typical for a traprock ridge

(*Aspicillia*, *Xanthoparmelia*, *Cladonia* (*Stereocaulon*?), *Aspicillia* and *Flavoparmelia* (Steve Messier, Personal Communication based on a photo review – author of Traprock Ridge Lichens, 2021).

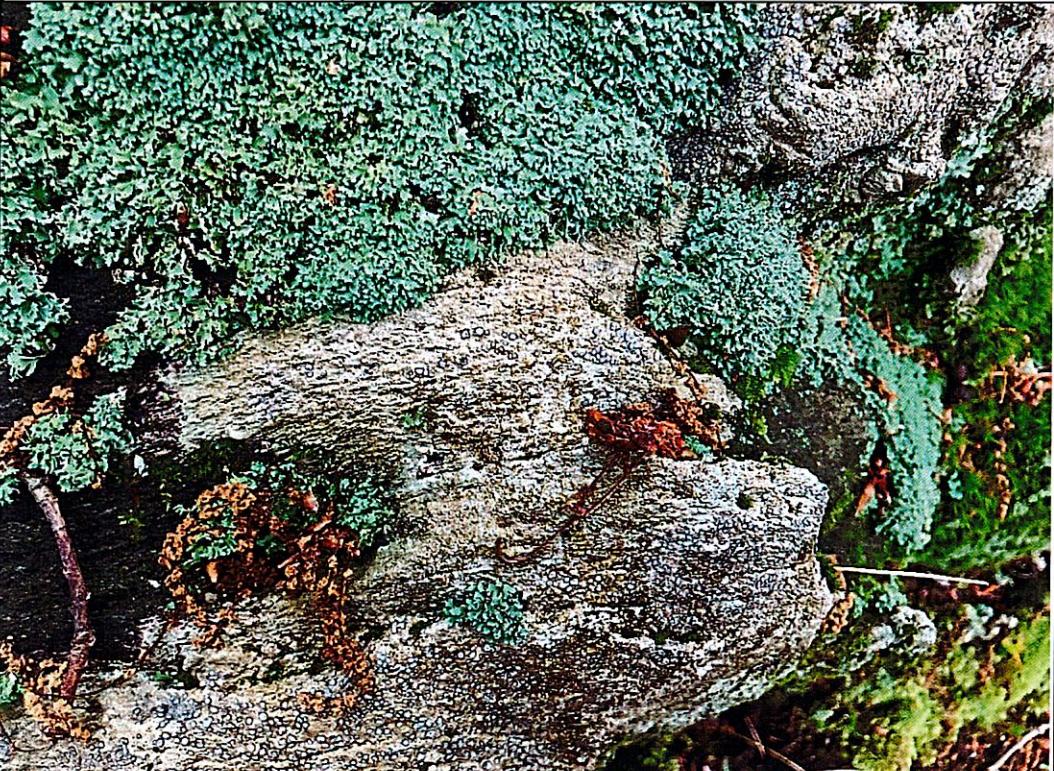
<b>DATE:</b> May 21, 2025	<b>FACING:</b> NA	<b>PHOTO NO.:</b> 12	<i>Comments:</i> Lichens on light, metamorphic rock.

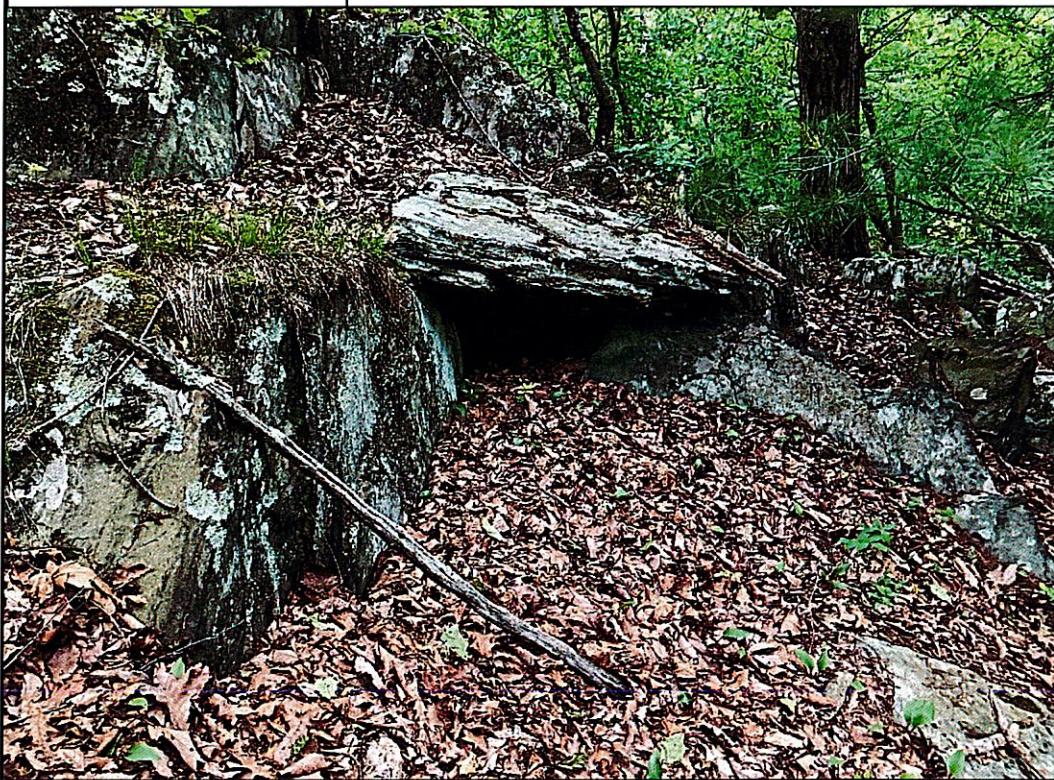
**PHOTO NO.:****13**

*Comments: Wildlife shelter beneath flat, horizontally bedded rock. Note white crustose lichens.*

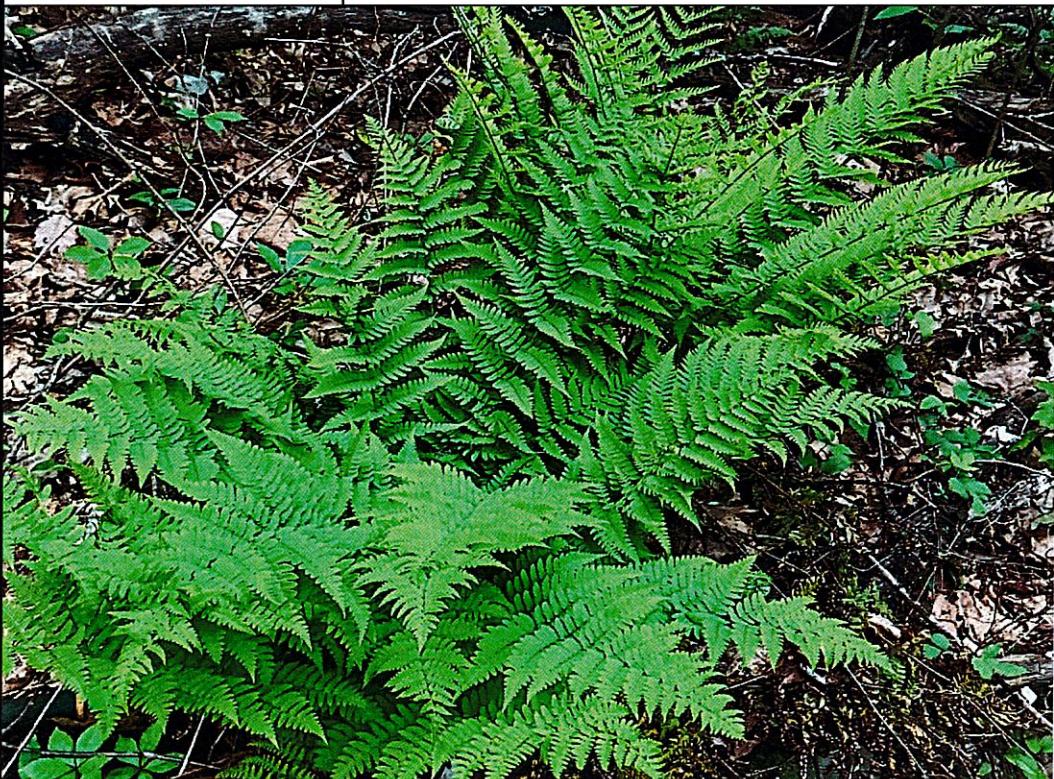
**PHOTO NO.:****14**

*Comments:  
Especially dense, vigorous marginal wood fern (*Dryopteris marginalis*) at base of layered, moisture trapping metamorphic bedrock.*

Interesting vegetation patterns were also noted on the open, exposed rock outcrops. In some areas multiple, closely spaced cracks between rock layers were vertical rather than horizontal, allowing water seepage, resulting in thick layers of moss on the rock surface and extremely lush plant growth in soil at the base of the exposed rock. This was not observed on several massive, foliated, but unfractured outcrops further east along the crest.
