Re: Wetland and Watercourse Delineation
804 Fountain Street & Wilbur Cross Parkway Right-of-Way, Woodbridge, Connecticut

WETLAND & WATERCOURSE MAP

**804 FOUNTAIN STREET
WOODBIDGE, CONNECTICUT**

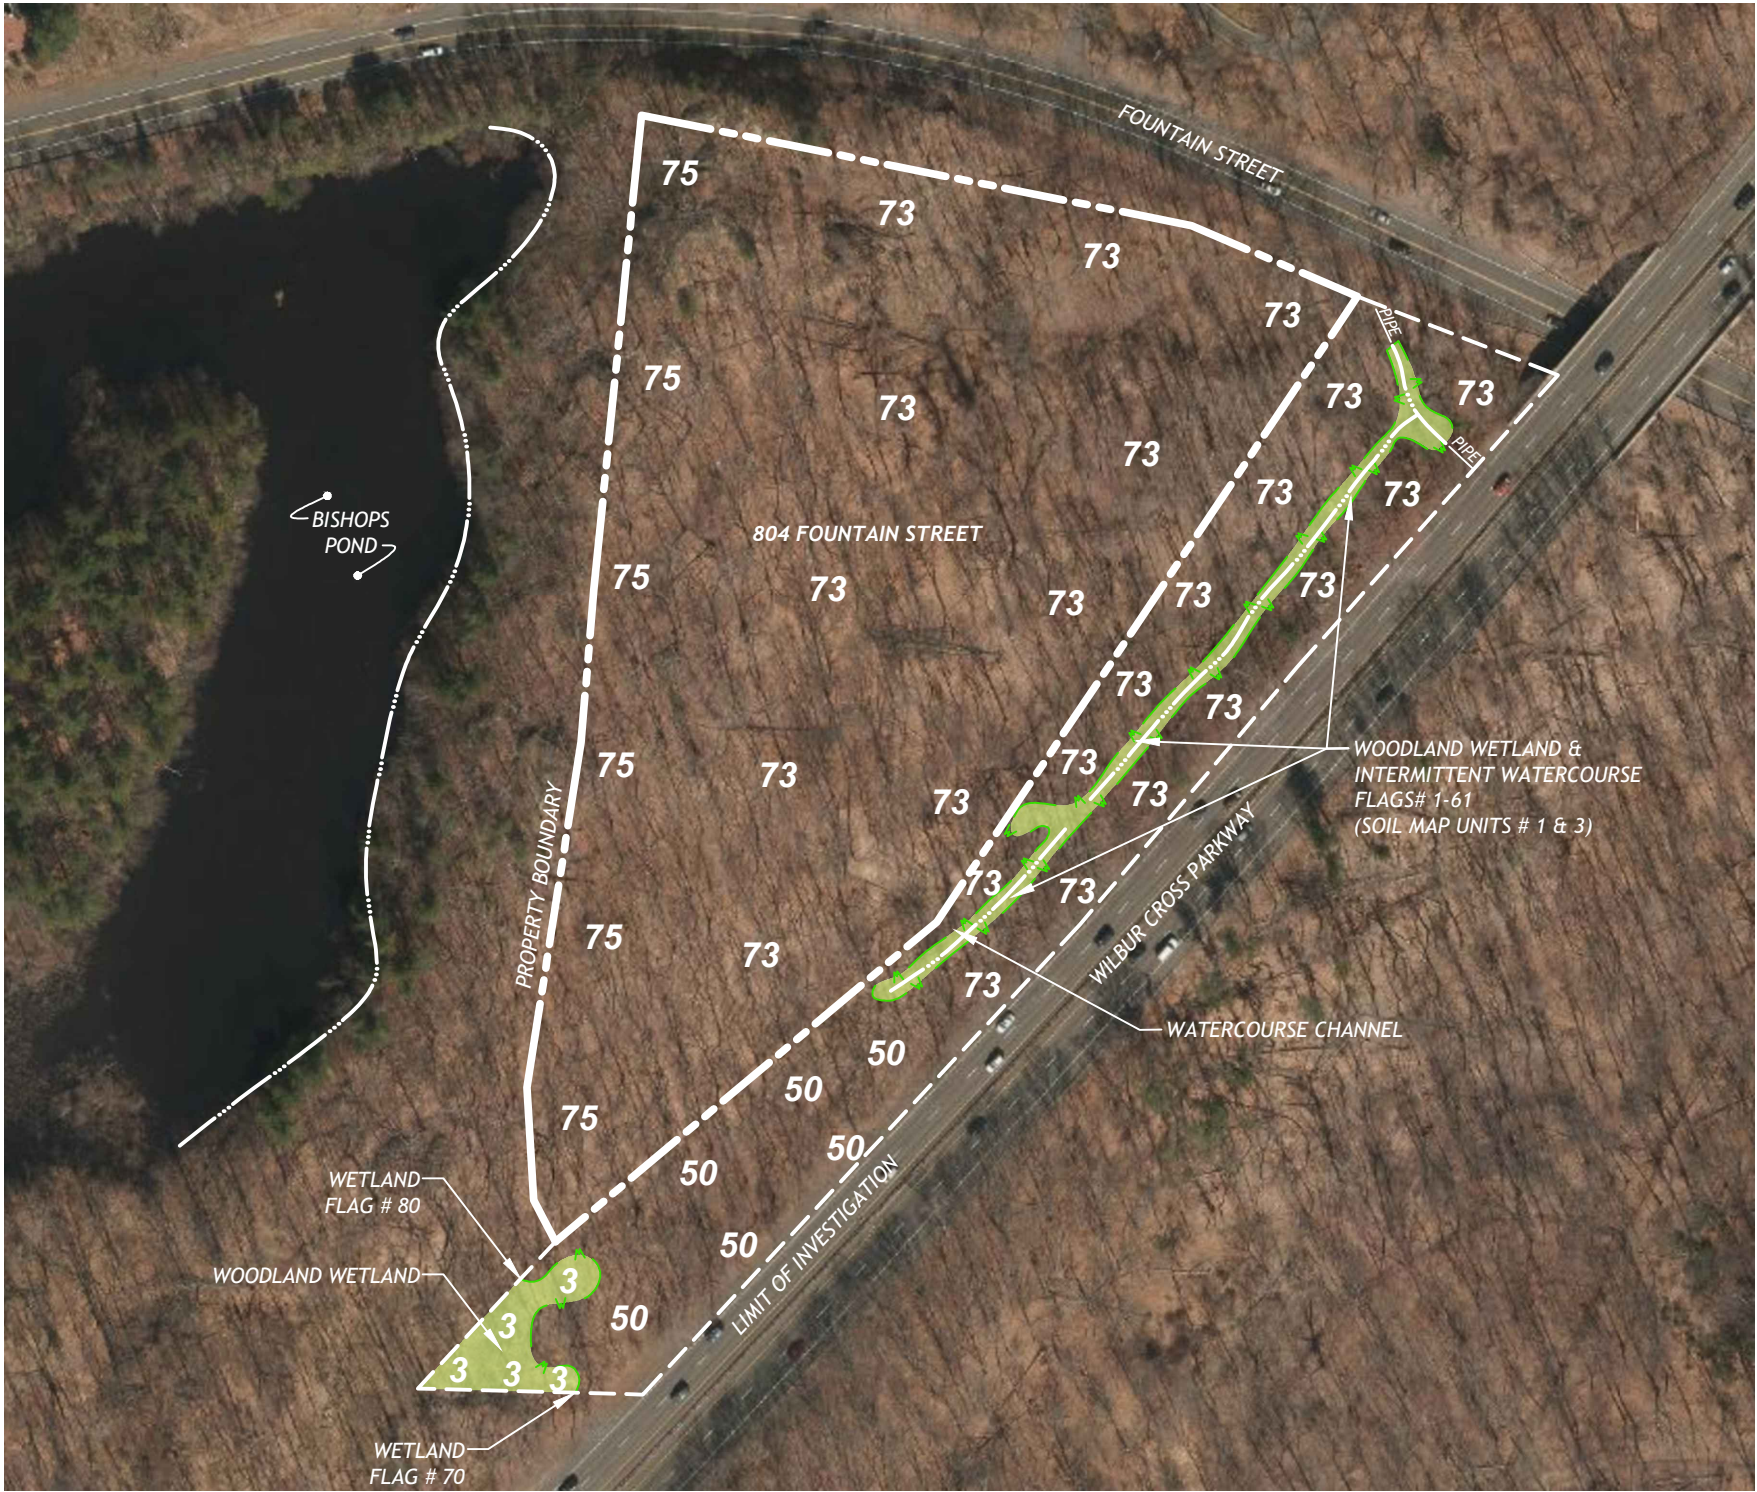
Two inland wetland and watercourse systems were identified and delineated. The first system, which is located in the western portion of the limit of investigation, is an intermittent watercourse that extends and flows from a culvert at the northernmost extent of the system and flows a short distance to another culvert which is located in the southeast. The majority of the system, however, extends and flows from south to north and combines with the first segment before exiting the property via a culvert, beneath the Wilbur Cross Parkway. The second system, which is located immediately south of 804 Fountain Street, is a woodland wetland. An apparent watercourse, Bishops Pond, is located west of the property. Wetland soils are primarily poorly drained fine and formed from glacial till deposits or are forming from human altered deposits. The approximate locations of the systems are

shown on the attached map. The boundaries of the systems were marked at the site with flags numbered 1 to 61 and 70 to 80.
